Krubbemölla byggnadsvård 2021

| <p>Reparation tak. Augusti 2021</p> | |

**Inspektion
kvarn
mekanik
210911**

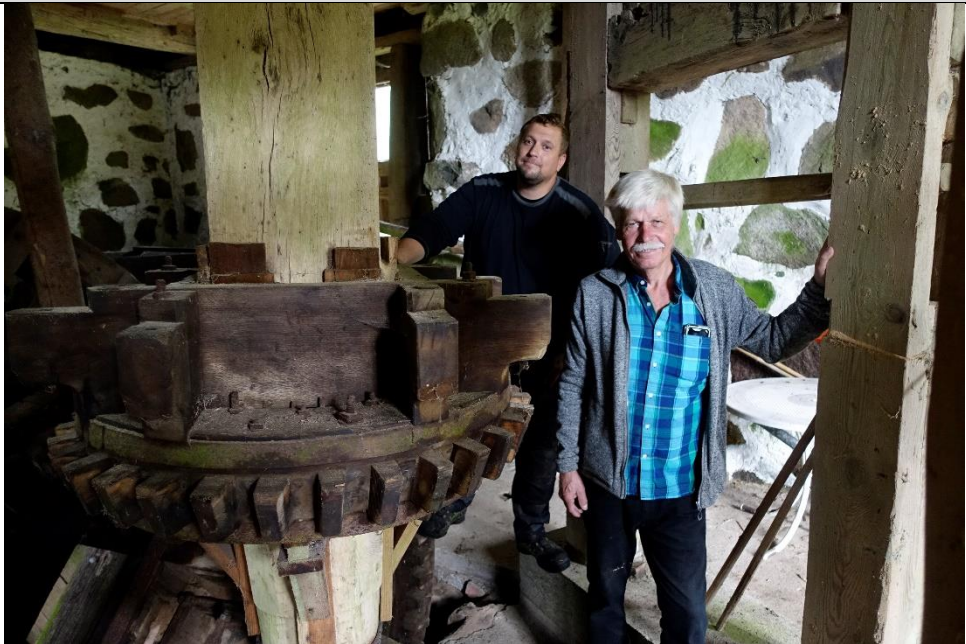
En inspektion av kvarnhjul, kuggjul och kvarndamm gjordes i lördags, 210911 av experterna Gunnar Zackrisson från Svensk Byggtradition och Ingmar Melin.

Dessa menar att det inte ska vara några större problem att köra möllan redan nu under hösten. Det begränsade vattenflödet bör trots allt räcka.
